REPORT OF THE DIRECTOR

ACCIDENT ON THE
MINNEAPOLIS, ST. PAUL & SAULI STE. MARIE RY

VOLTAIRE, N.DAK

INVESTIGATION NO. 2246

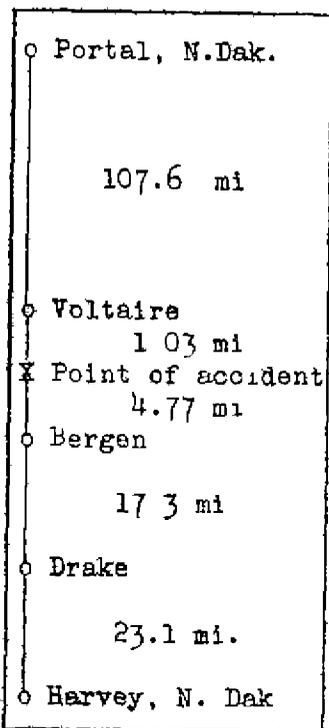
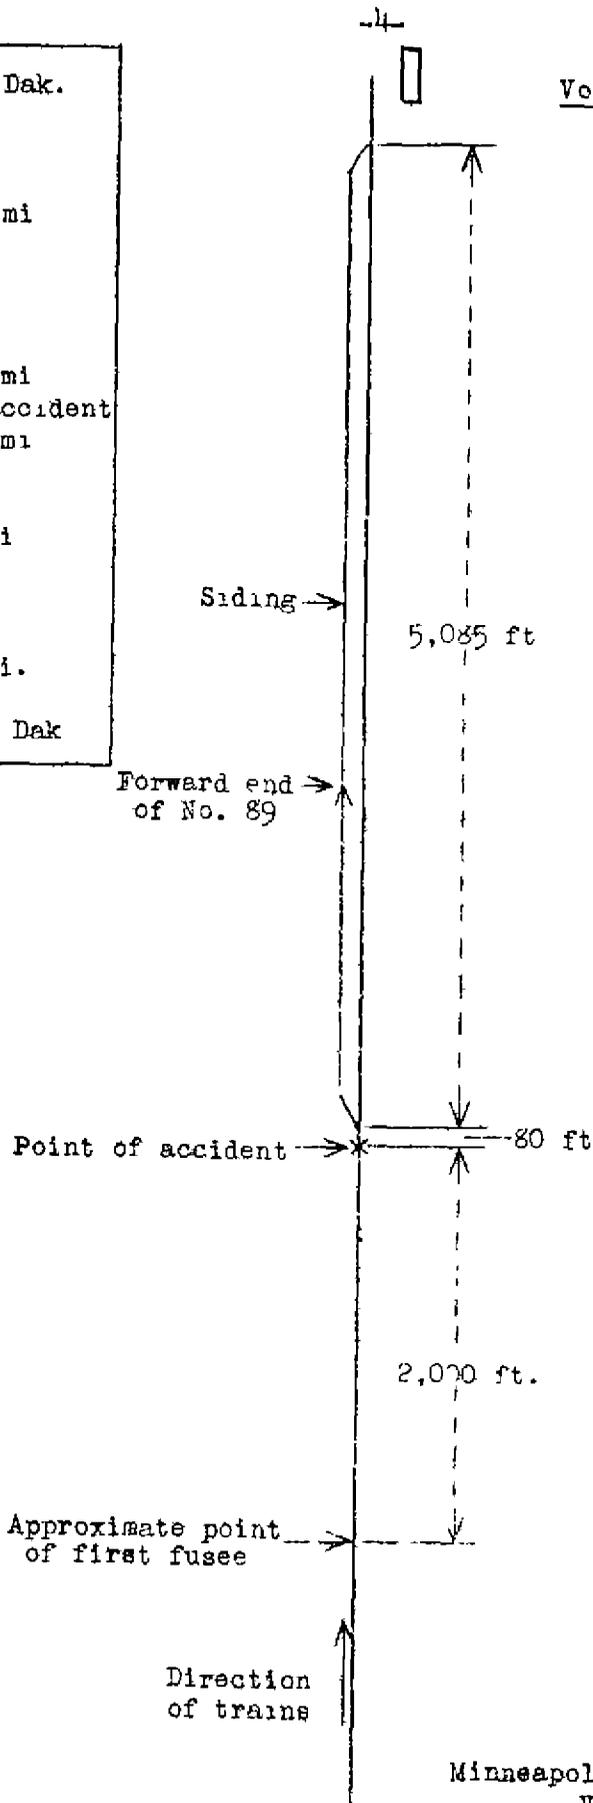
Inv. No. 2246
 Minneapolis, St. Paul & Sault Ste. Marie
 Voltaire, North Dakota
 Jan. 20, 1938

Voltaire station

This accident occurred on the Fourth Subdivision of the Minnesota Division which extends between Harvey and Portal, N.Dak., a distance of 153.8 miles. This is a single-track line over which trains are operated by timetable, train orders, and a manual block-signal system. The accident occurred 1.035 miles east of the station at Voltaire; approaching this point from the east the track is tangent and practically level for a distance of more than five miles. A siding about 5,085 feet in length parallels the main track on the south, the west switch of which is located approximately 300 feet east of the depot; the accident occurred at a point about 80 feet east of the east switch of the siding.
